TEST REPORT

No. : FTS200426003M01A1-E

Sample Name : Disposable cleaning clothes
Sample Model : Medium
Sample lot number : 20200418
Sample material : PE
Supplier : Jiangsu Jiawen Medical Supplies Co.,Ltd.
Accepting State : No abnormality
Test Quantities : 1PC
Receiving Date : 2020.04.26
Test Period : 2020.04.28-2020.04.29
Test Request : Test according to customer requirement
Test Method(s) : Please refer to next page(s).
Test Result(s) : Please refer to next page(s).

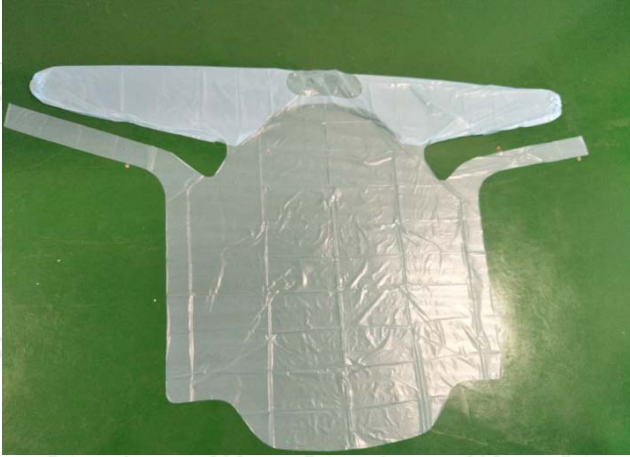
Test Items	Cutting and sewing	Sample Quantity	1PC
Test standard	Test according to customer requirements	Test Environment	23.1℃, 49%RH
Test Time	2020.04.28-2020.04.28	Conclusion	Pass
Test Condition	Observe the tailoring and sewing of the clothes visually.		
test result	There is no burr, leakage or crack at the cutting and sewing places.		
defining principle	No burr, leakage or crack is allowed at the cutting and sewing positions.		
Conclusion	Pass		
Remarks:			
	Test photos

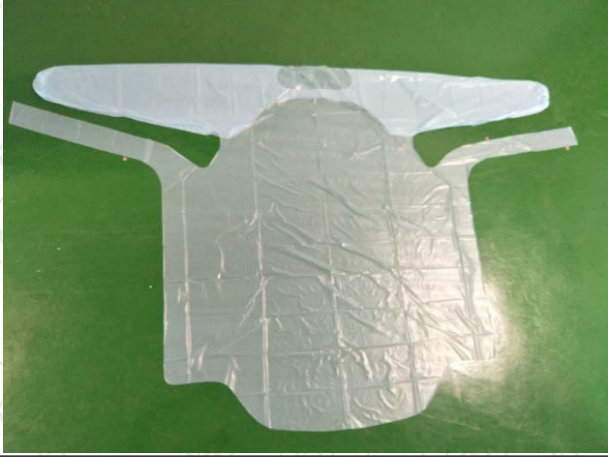
Test photos	
Sample photo	Before test (transverse)

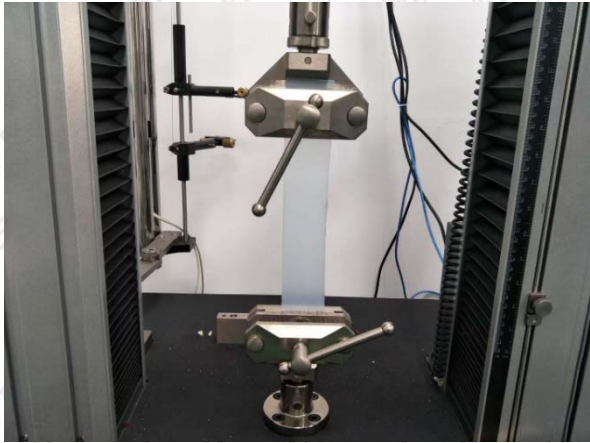
In test (transverse)	After test (transverse)

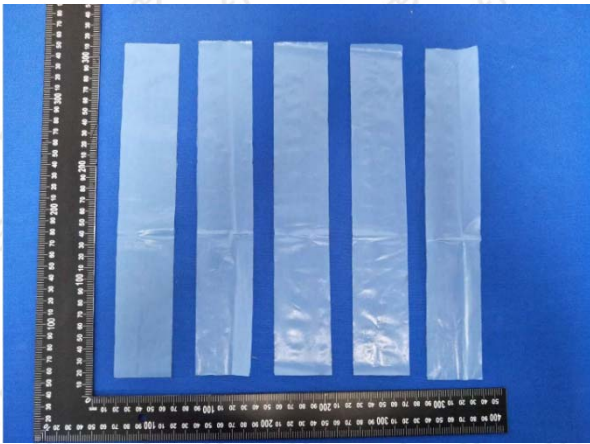
Before test (longitudinal)	In test (longitudinal)
